# Manhole Inspection Summary

Manhole # S21II\_041MH

Insp Date: **6/25/07 6:56 AM**

**Location** Address: **1713 MOUNT-FULTON ALLEY**

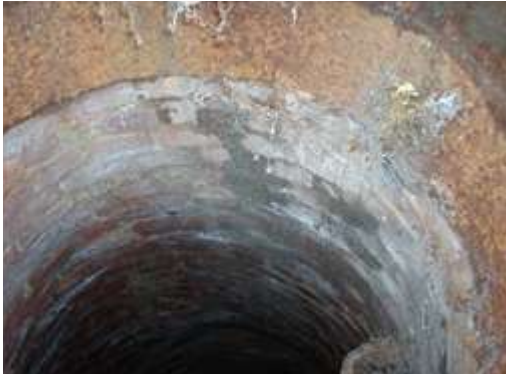
Defect 2

Infiltration: ☐ None ☐ Joint ☐ Cracks ☐ Mortar ☐ Roots ☒ Wall

INFILTRATION EVIDENCE ON CORBEL

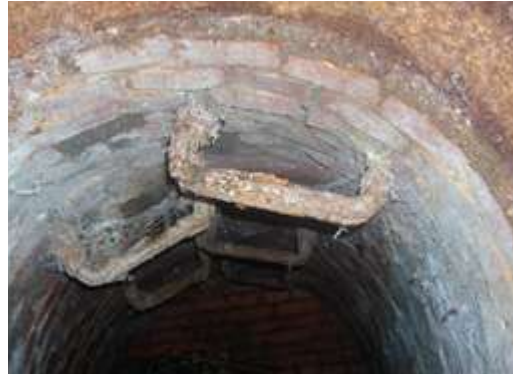
Defect 1

**Steps** Count: **6** Missing: **0** ☒ Corroded

CORRODED STEPS

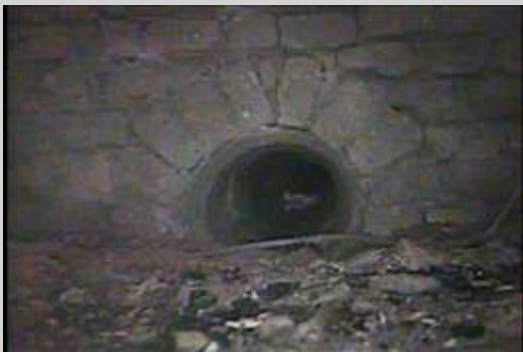
12 O'Clock Outflow

8 in. Circular Gravity Sewer  
Pipe Out @ 12 O'Clock

Pipe Height: **8.4** (in.) Rod and Bar (Angled)  
Pipe Material: **Clay** ☐ Pipe Lined  
Invert Depth: **10.43** (ft.) Flow Characteristics: **None**  
Deposits: ☒ None ☐ Mud ☐ Sludge ☐ Debris ☐ Grease  
Silt Depth: (in.) Deposits Extent:  
Infiltration: **None** Pipe Seal Cond: **Broken**

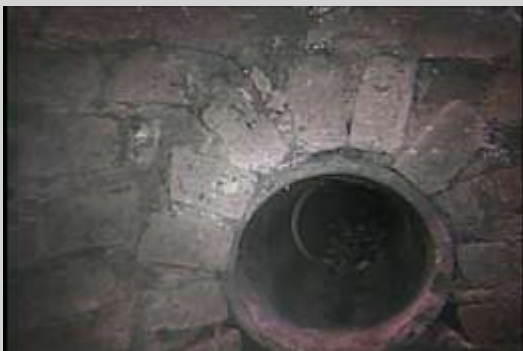
9 O'Clock Outflow

8 in. Circular Gravity Sewer  
Pipe Out @ 9 O'Clock

Pipe Height: **8.4** (in.) Rod and Bar (Angled)  
Pipe Material: **Clay** ☐ Pipe Lined  
Invert Depth: **7.49** (ft.) Flow Characteristics: **None**  
Deposits: ☒ None ☐ Mud ☐ Sludge ☐ Debris ☐ Grease  
Silt Depth: (in.) Deposits Extent:  
Infiltration: **None** Pipe Seal Cond: **Broken**
